# Navajo Abandoned Uranium Mine Site Screen Report

**Delter AUM Site**

**Navajo AUM Eastern Region**

**May 2009**

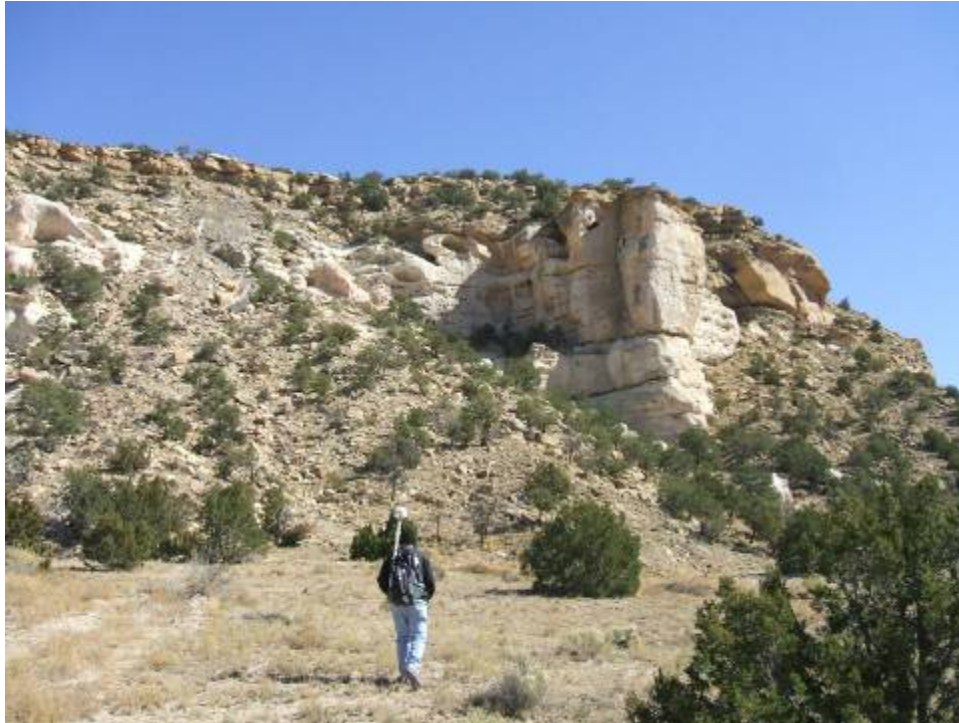
Reclamation status of the mine site is currently unknown. No visible signs of reclamation were observed. No waste piles, adits, or other mine features were observed during the site visit, the site was located along a cliff / landslide area..

Photo 1. Delter mine site hill side, towards the east

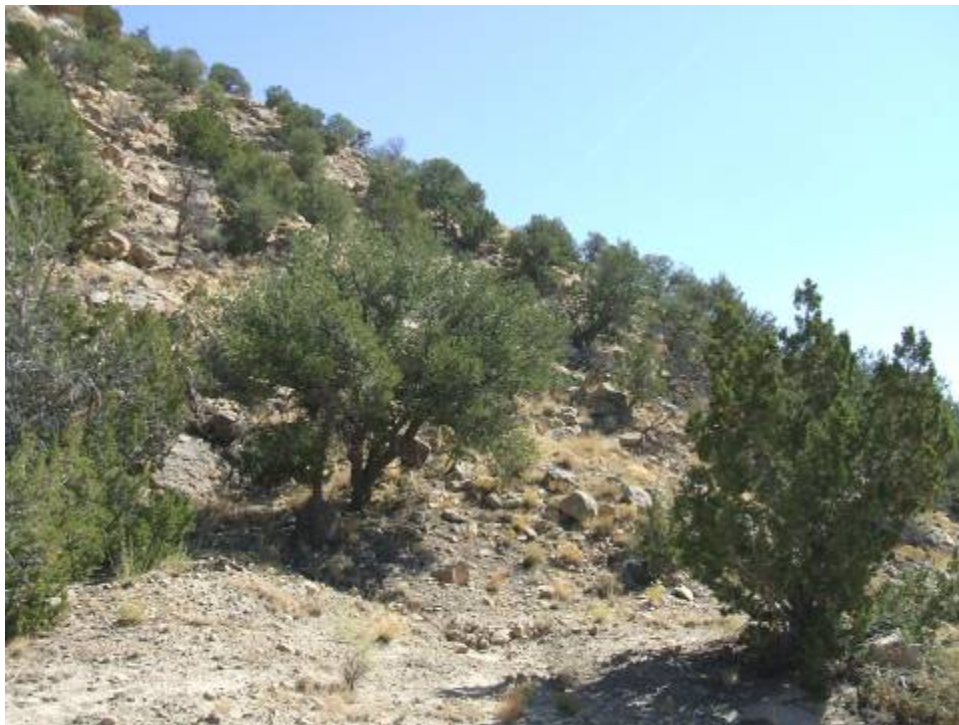
Photo 2. Delter mine site hill side, towards the southeast

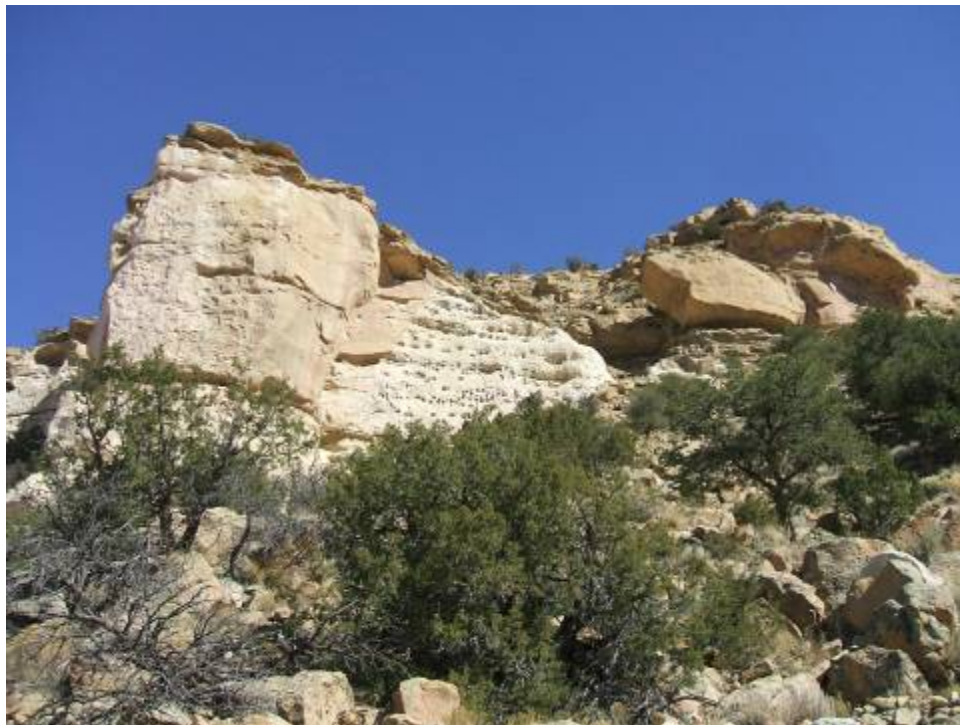
Delter mine consists of an area of 11,663.91 square meters. The site was located along a large cliff / landslide area. No historical site information was available.

Photo 3. Delter mine site cliff face, towards the east

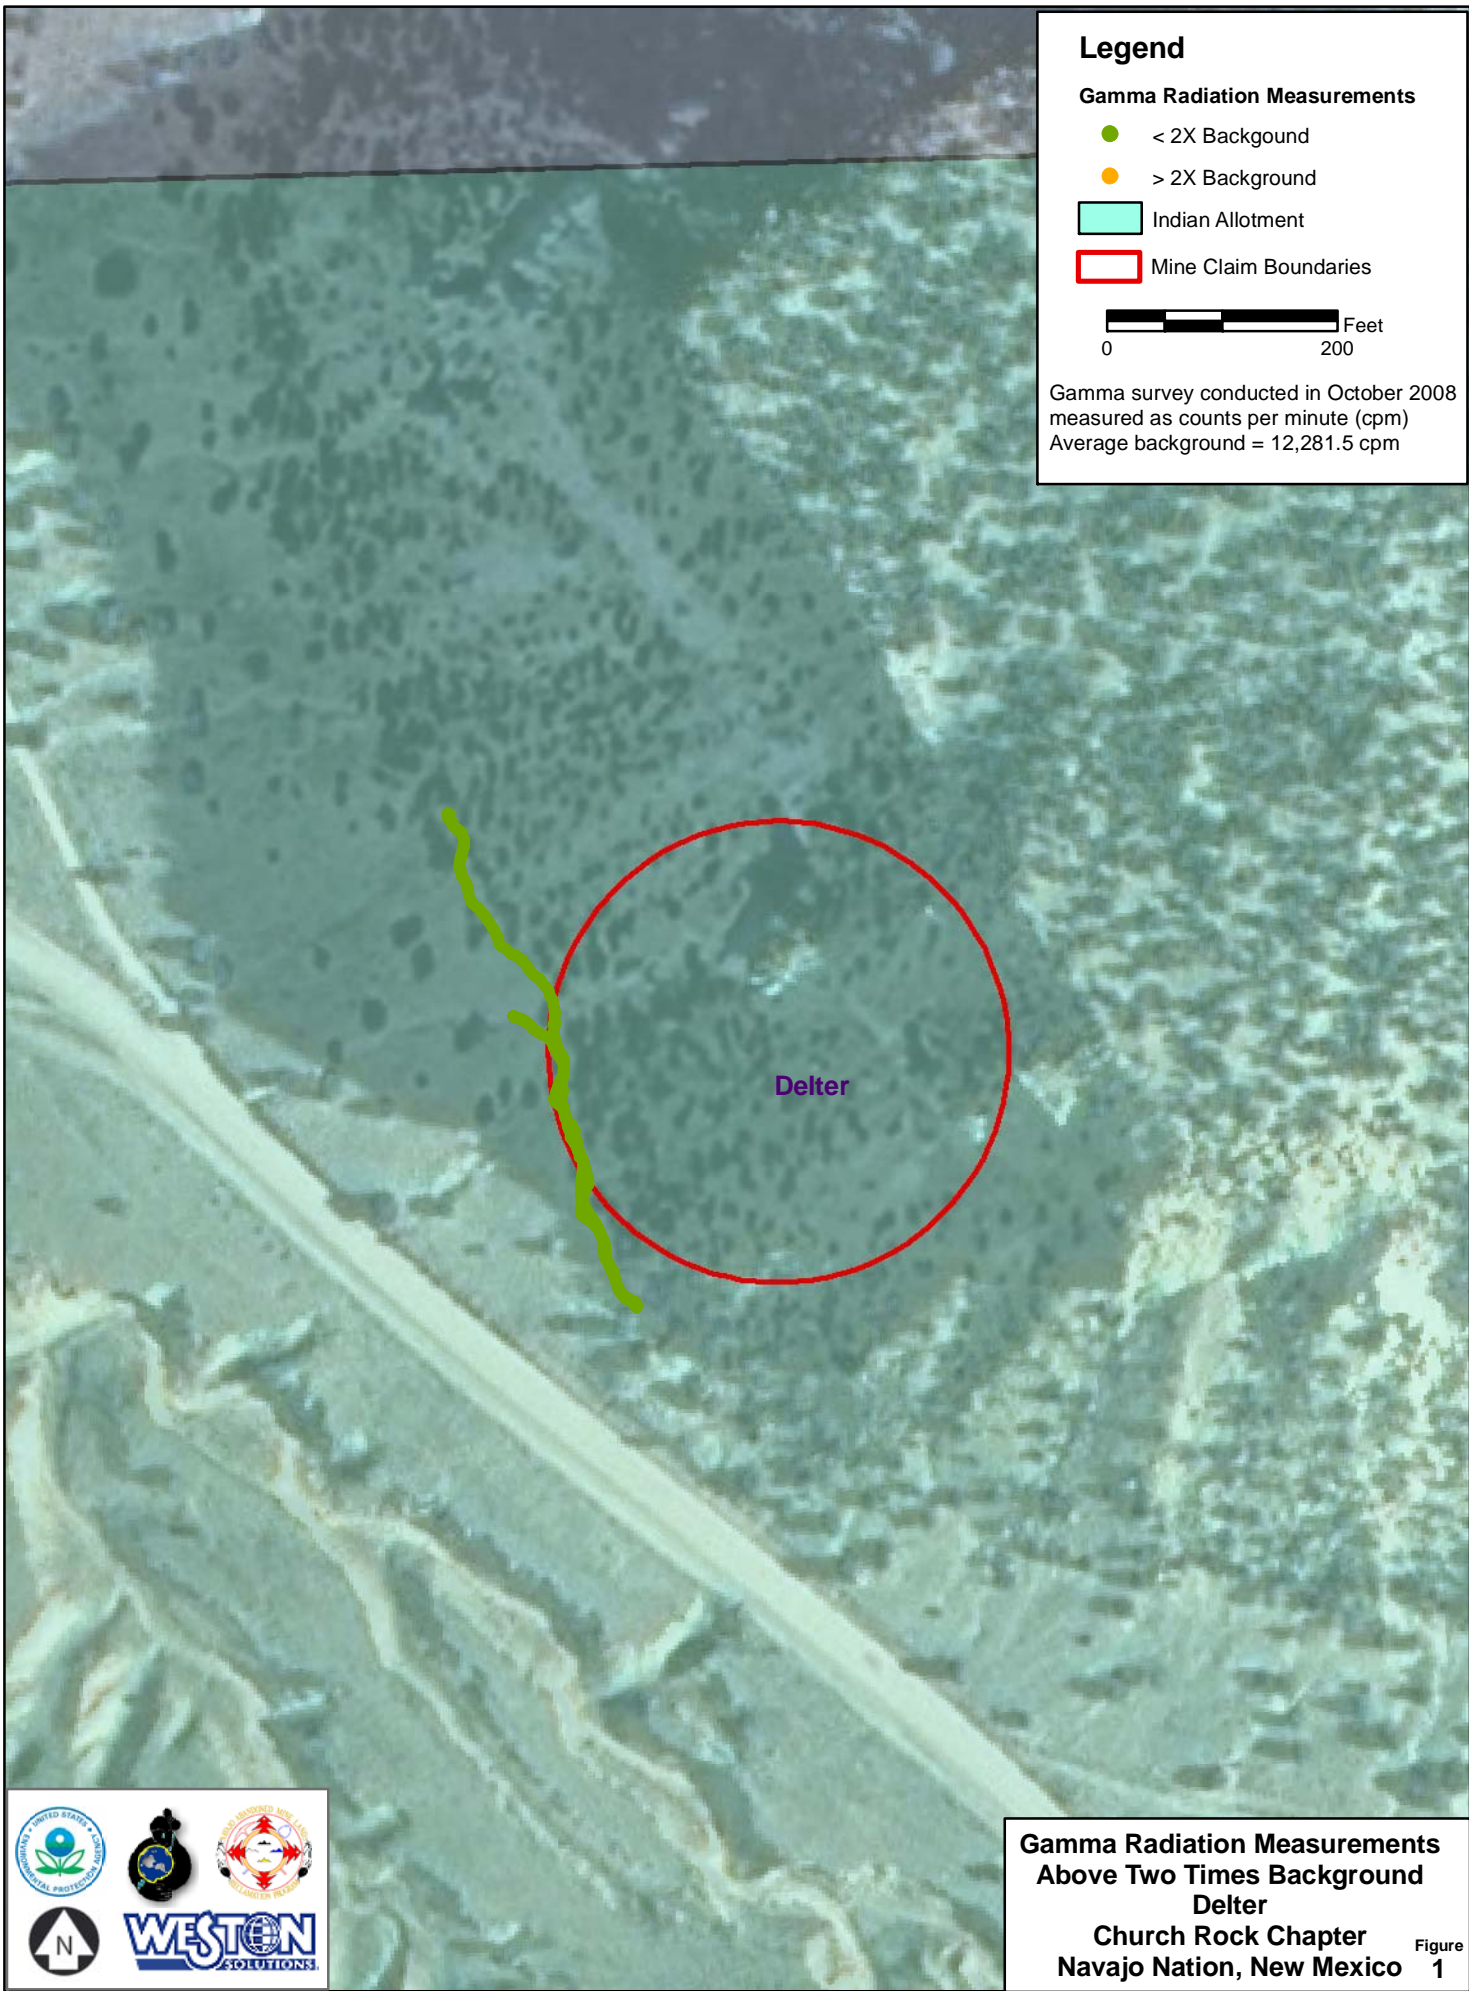
**Gamma Radiation Measurements  
Above Two Times Background  
Delter  
Church Rock Chapter  
Navajo Nation, New Mexico**

A total of 514 gamma radiation measurements were collected from mine sites, ranging from 9,706 cpm to 56,632 cpm. The measurements are represented in Figures 1 and 2.

Gamma survey conducted in October 2008  
measured as counts per minute (cpm)  
Average background = 12,281.5 cpm
